ANNUAL REPORT FOR 2010

**Holland Creek Site M Mitigation Site
Madison County
TIP No. R-2518A**

Prepared By:
Natural Environment Unit & Roadside Environmental Unit
North Carolina Department of Transportation
December 2010

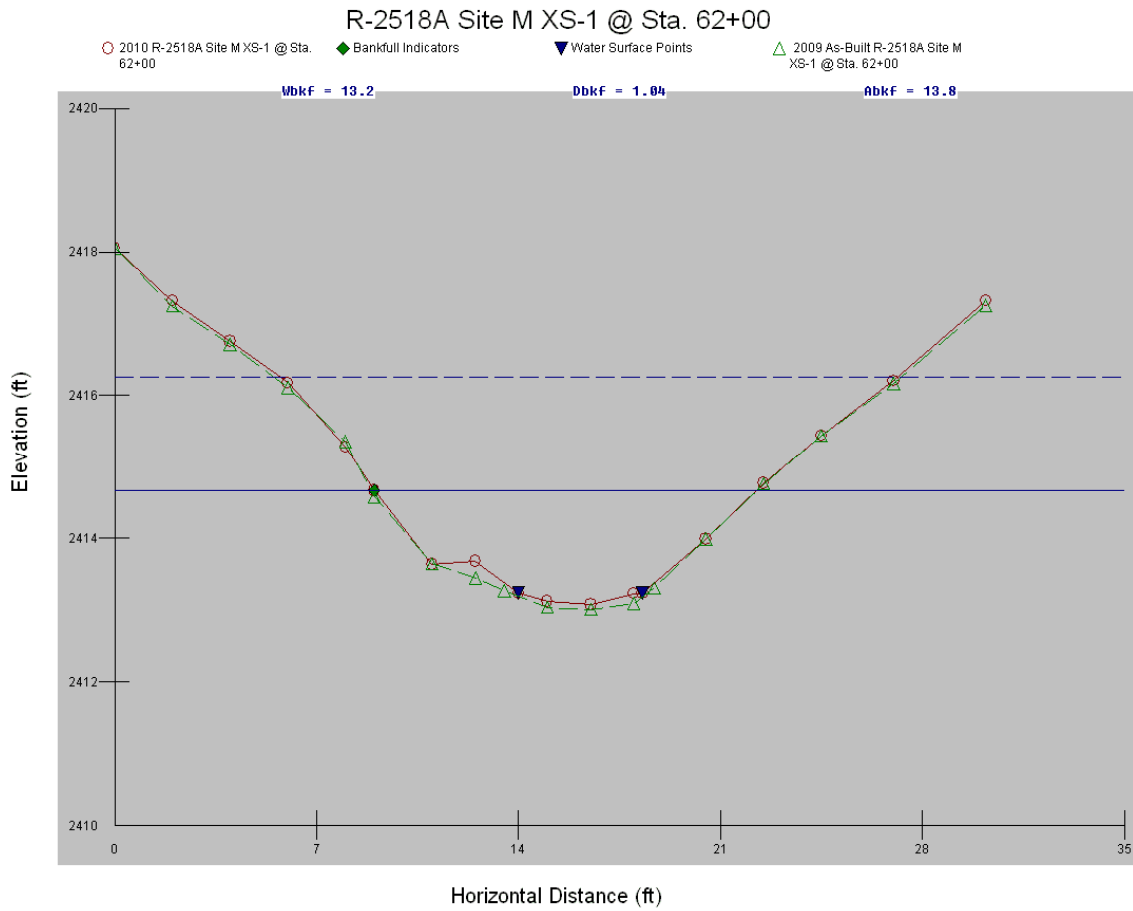
Based on comparisons of the As-Built to Year 1 monitoring data, all of the cross sections appear stable with little or no active bank erosion. Graphs of the cross sections are presented in Appendix A. Future survey data will vary depending on actual location of rod placement and alignment; however, this information should remain similar in appearance. The longitudinal profile showed that the channel was stable for the 2010 monitoring evaluation. Pebble counts were not required per the permit conditions and therefore were not completed.
